Woorim Beach Shoreline Erosion Management Plan

Shoreline Erosion Management Plan

Prepared For: Caboolture Shire Council

Prepared By: BMT WBM Pty Ltd (Member of the BMT group of companies)

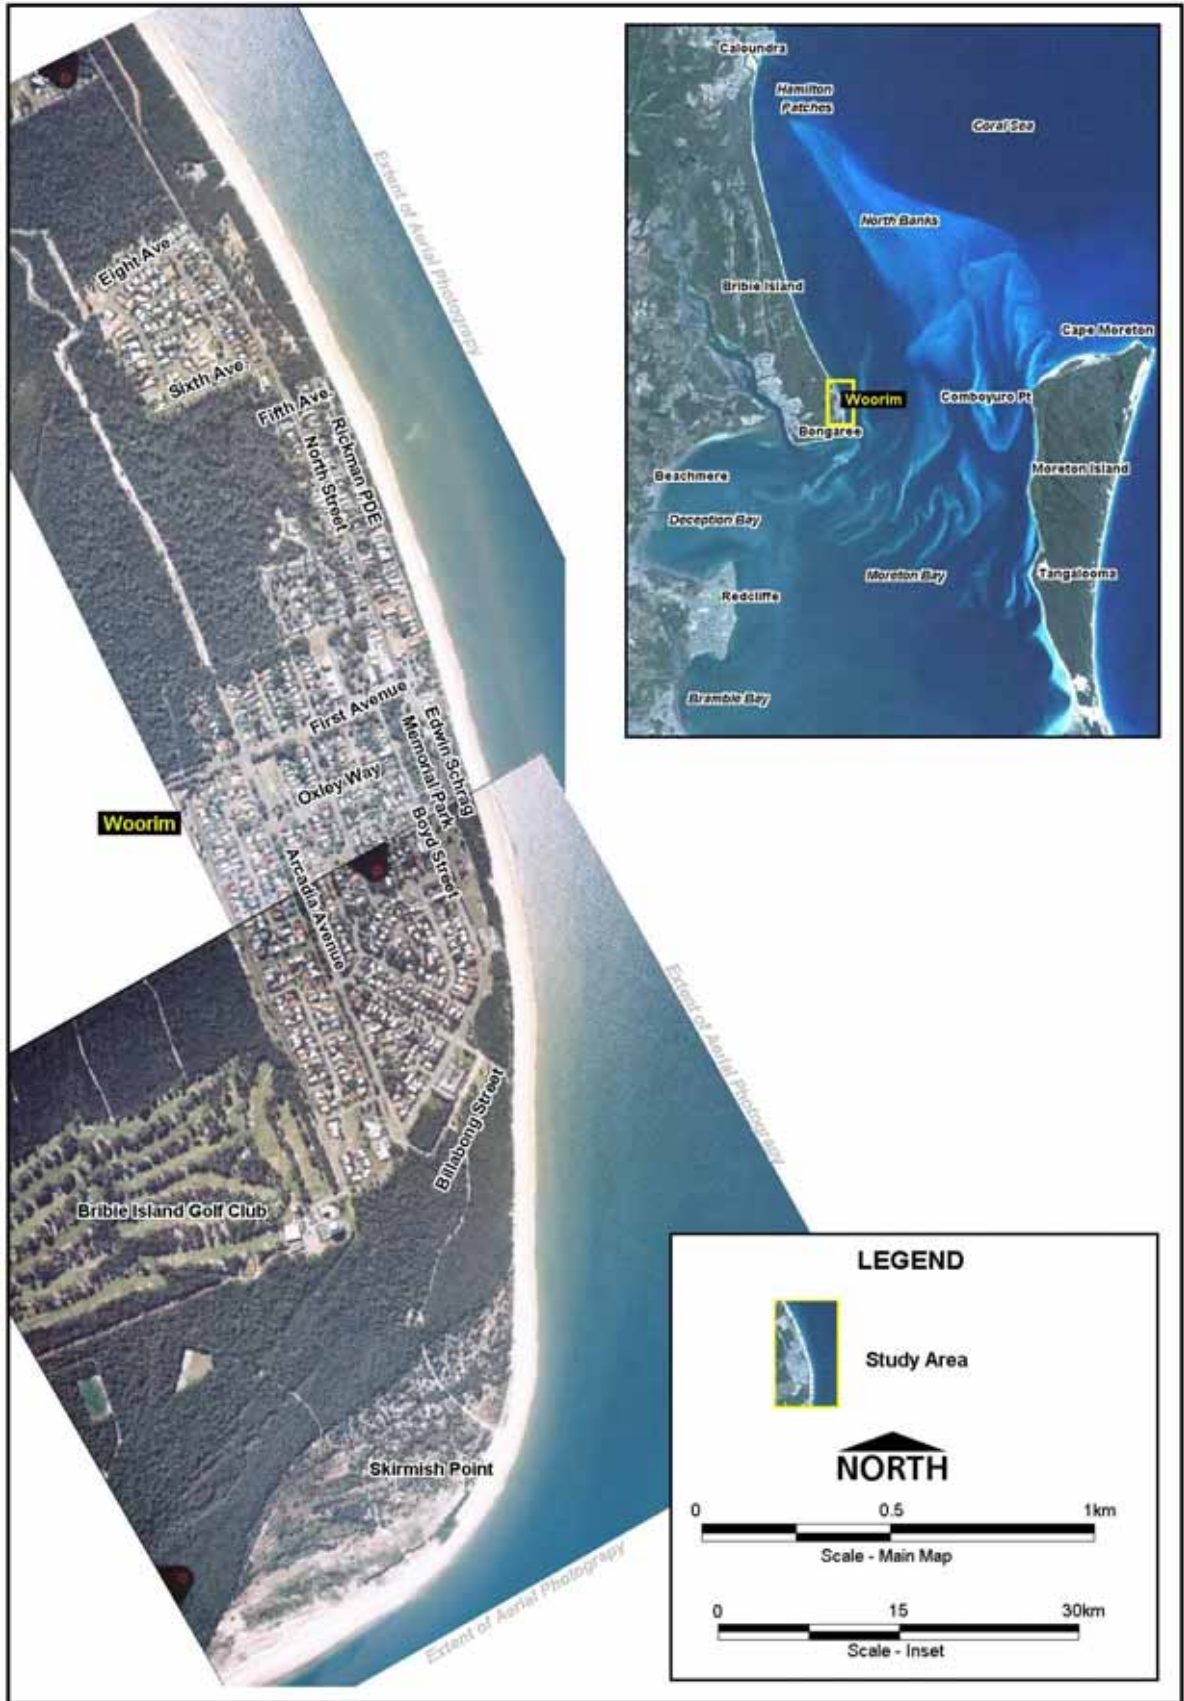
Figure 1-1 Woorim Beach

Woorim Beach is located towards the southern end of the east coast of Bribie Island (Figure 1-1). The beach sweeps in a gentle smooth curve around the southeastern part of Bribie Island. It faces east and is exposed to east to northeast ocean waves, but receives considerable protection by Moreton Island from the predominant southeast swell waves. The beach is exposed to winds and locally generated wind waves from the southeast to north sectors. The beach is backed by a substantial dune typically 5-8 metres in height.
